Manhole Inspection Summary

Manhole # **S13GG_035MH**

Insp Date: **11/8/07 2:35 PM**

Location Address: **2810 PRESBURY ST**

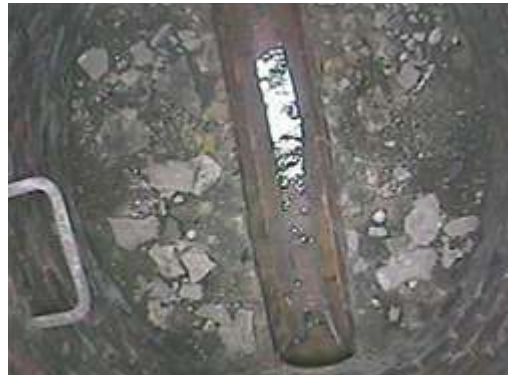
Top View

Frame Offset: **3** (in.) Condition: ☐ Sound ☒ **Cracked** ☐ Leaks

Condition: ☐ Sound ☒ **Cracked** ☐ Root Intrusion ☒ **Loose Brick** ☐ Deteriorated

CRACKED CHIMNEY, LOOSE BRICKS

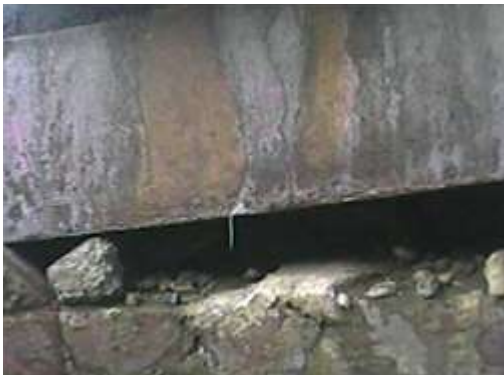
Defect 1

CRACKED CHIMNEY, LOOSE BRICKS

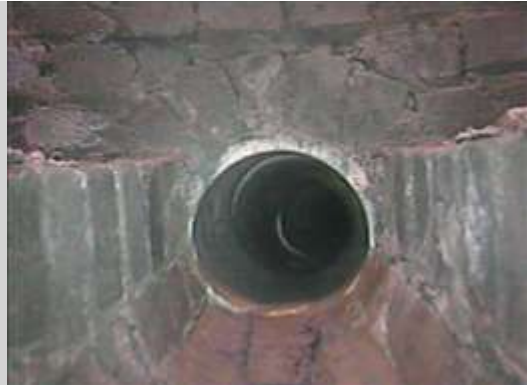
12 O'Clock Outflow

8 in. Circular Gravity Sewer
Pipe Out @ 12 O'Clock

CRACKED CHIMNEY, LOOSE BRICKS

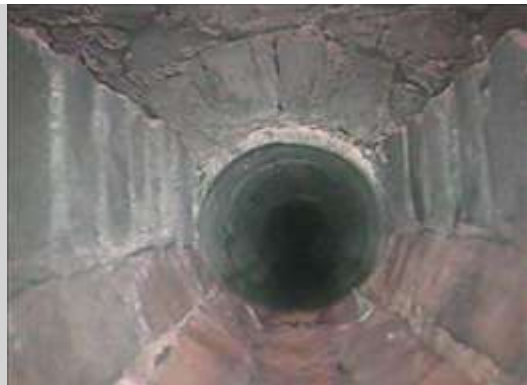
6 O'Clock Inflow

8 in. Circular Gravity Sewer
Pipe In @ 6 O'Clock

CRACKED CHIMNEY, LOOSE BRICKS
